CONNECTICUT RIVER BASIN PLYMOUTH, CONNECTICUT

OLD MARSH POND DAM
CT 00285

PHASE I INSPECTION REPORT
NATIONAL DAM INSPECTION PROGRAM

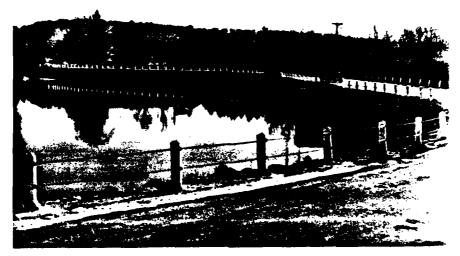
Overview of dam from right abutment of dam.
